Manhole Inspection Summary

Manhole # S23GG_042MH

Insp Date: **10/9/07 9:08 AM**

Location Address: **1520 CAREY ST**

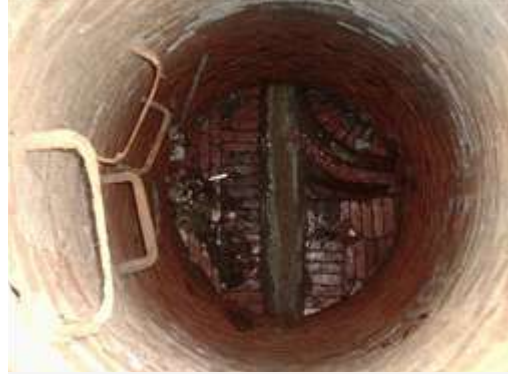
Top View

Corroded steps. Bench debris.

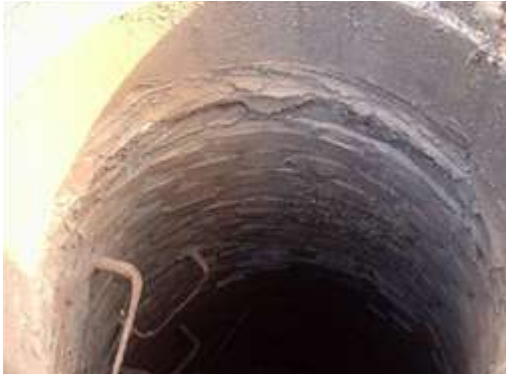
Defect

Frame leaks. Adjustment deterioration and infiltration. Barrel infiltration.

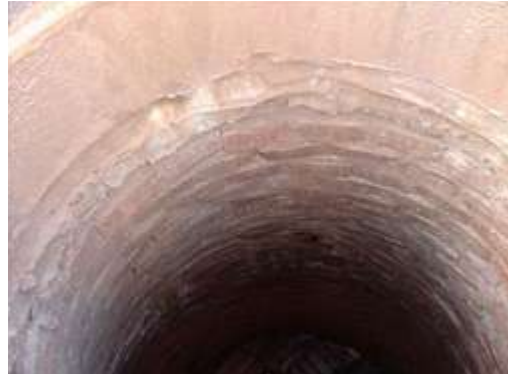
Defect

Frame leaks. Adjustment deterioration and infiltration. Barrel infiltration.

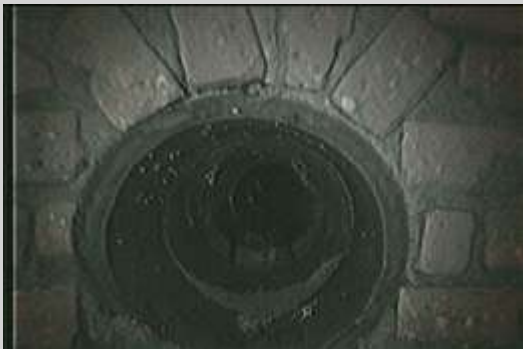
8 in. Circular Gravity Sewer Pipe In @ 3 O'Clock

Infiltration: **Evidence** Pipe Seal Cond: **Unknown**

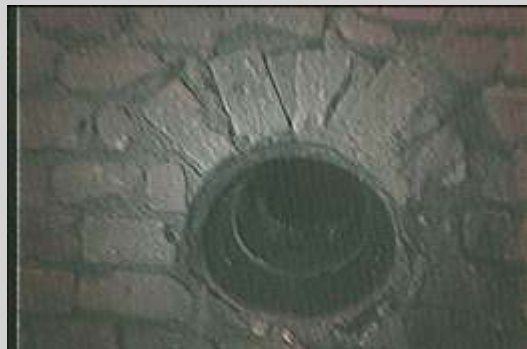
Pipe In @ 6 O'Clock

Infiltration: **Evidence**
